# Manhole Inspection Summary

Manhole # S21M\_\_049MH

Insp Date: **4/1/08 1:36 PM**

**Location** Address: **437 cole-wilkens alley**

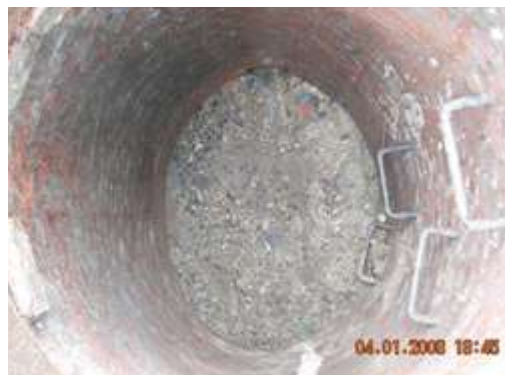
Top View

Condition: ☐ Sound ☐ Cracked ☐ Root Intrusion ☐ Deteriorated ☐ Leaks ☒ **Debris**

channel debris

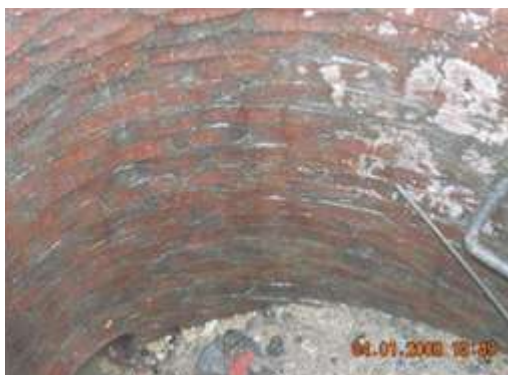
Defect 2

Infiltration: ☐ None ☒ **Joint** ☐ Cracks ☐ Mortar ☐ Roots ☐ Wall

infiltration @ barrel joint, channel debris

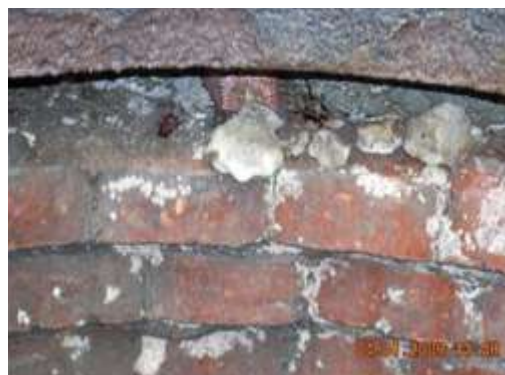
Defect 1

Condition: ☐ Sound ☐ Cracked ☐ Root Intrusion ☒ **Loose Brick** ☒ **Deteriorated**

deteriorated chimney

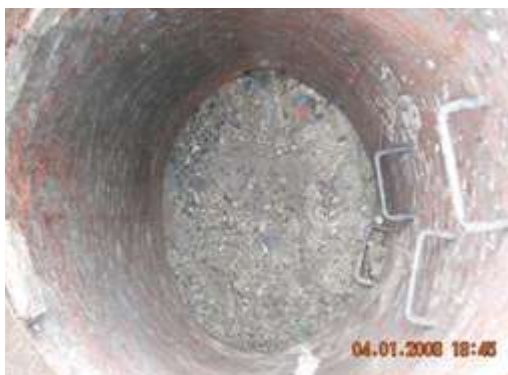
Defect 3

Loose Brick in Chimney, channel debris

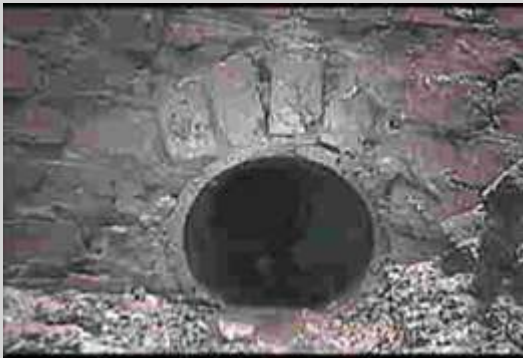
12 O'Clock Outflow

8 in. Circular Gravity Sewer  
Pipe Out @ 12 O'Clock

Infiltration: **None** Pipe Seal Cond: **Sound**
